Archeological Monitoring of Parging
Trenches
600/602 North Second Street
Maggie L. Walker National Historic Site
Richmond, Virginia

Allen H. Cooper
National Park Service
Mid-Atlantic Regional Office
Philadelphia, Pennsylvania
1994

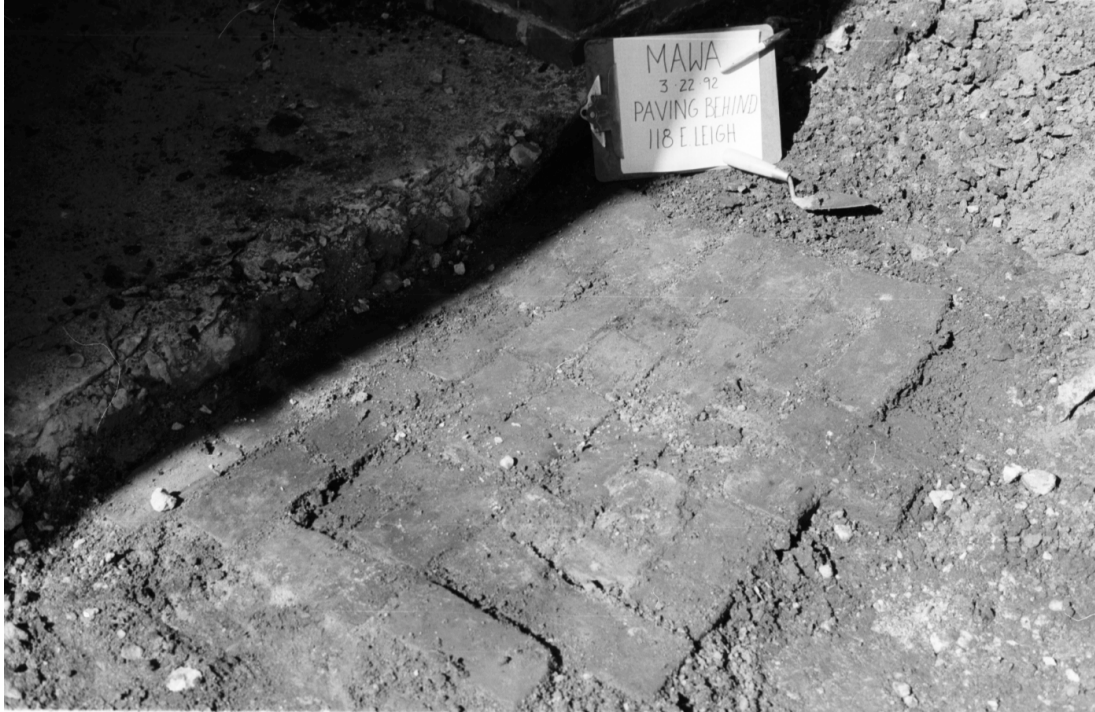
Figure 4: Photograph of paving feature between 116 and 188 East Leigh Street.

Figure 5: Drawing of plan view of paving feature between 116 and 118 East Leigh Street.

The paving feature behind 118 East Leigh Street was constructed of building brick, extending 2.6 feet from the intersection of the alleys between 116/118 East Leigh and 600 Second Streets (Figures 4 and 5). Subsurface probing and direct observation where it is pierced by a downspout indicated that this feature extends to within 7.2 feet of the south juncture of the two buildings. It begins slightly north of the alley door of 116 East Leigh and certainly is related to the door's location. The paving mostly covered by cement paving except the portion which extends into the alley which was uncovered by excavation. Beginning immediately beneath the surface, the paving rests directly on the layer of ash and cinder which overlays the entire site. Its date is ambiguous since the date of deposition for the ash layer presumably postdates 1915.

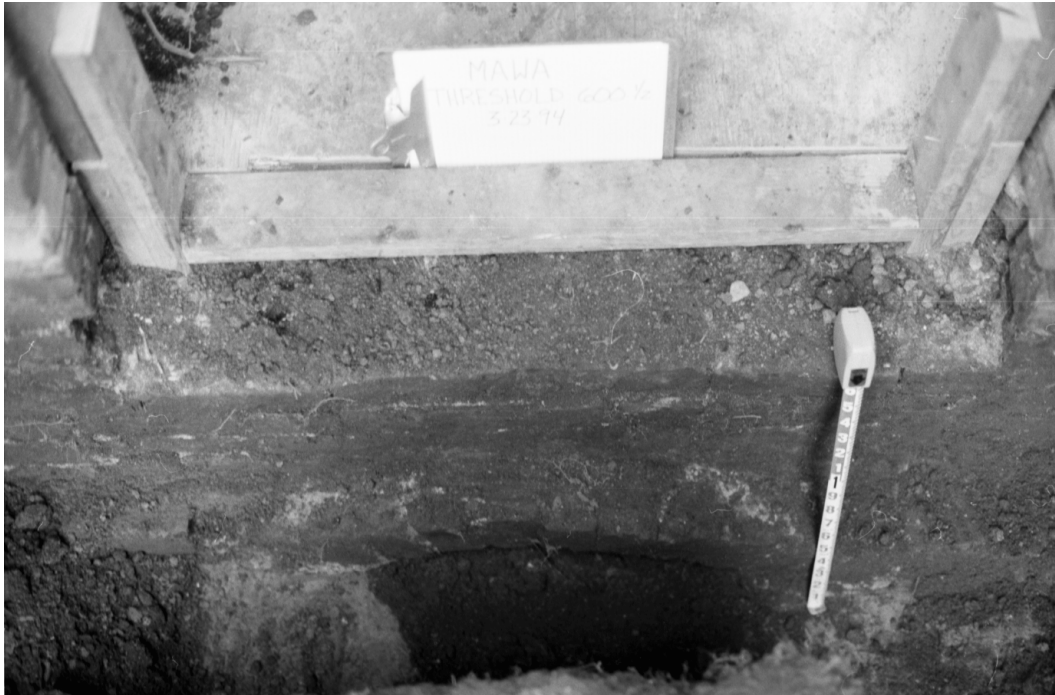
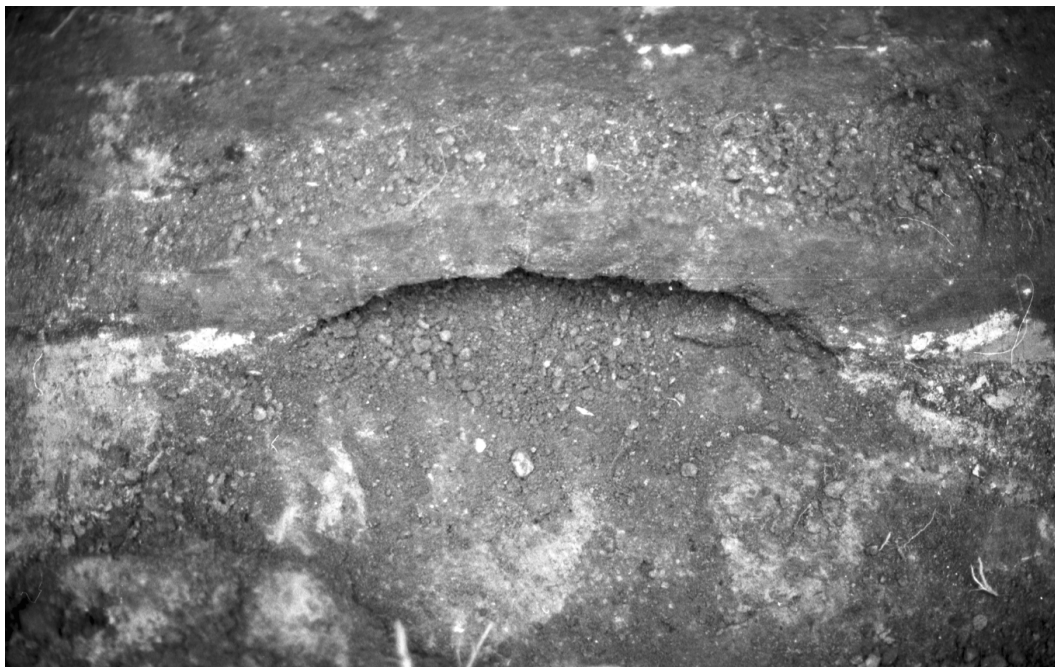
Figure 6: Relieving arch in west foundation of 600 1/2 North Second Street.

Figure 7: Relieving arch in west foundation of 600 1/2 North Second Street.

The relieving arch beneath the rear door to 600 Second Street (Figures 6 and 7), contained a shallow trench which ran through the arch and beneath the foundation. The depth of the arch suggests its function as an airway, since only a small portion of its face extended above the surrounding clay subsoil. A partial basement in this structure was identified during interior rehabilitation work by the Regional Archeologist. This arch probably provided ventilation to that space.
